# THE • INTERIOR • BUILDING ITS • ARCHITECTURE • AND • ITS • ART

PRESERVATION CASE STUDIES

David W. Look, AIA  
Carole L. Perrault

U.S. Department of the Interior  
National Park Service  
Preservation Assistance Division  
1986

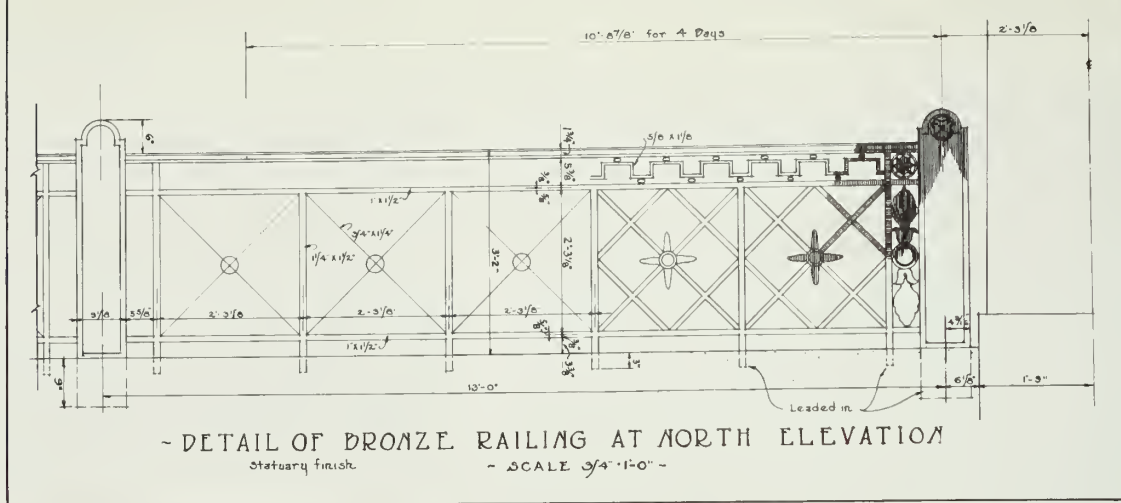
7

7. DETAIL OF BRONZE RAILING, NORTH ELEVATION, EXTERIOR. Drawing of the bronze railing installed along the north elevation to guard the window areaway. The ornate railing extends from the pylons flanking the north entrance to the corners of the building. The bronze railing design is Model No. 104 (see Figs. 25 and 283). Detail of Drawing No. 117, by Wellborn Smith, May 1, 1935. Document stored at the National Record Center, Suitland, Maryland, Record Group 121-76-301, Box 85, No. DC 0020 ZZ 146.

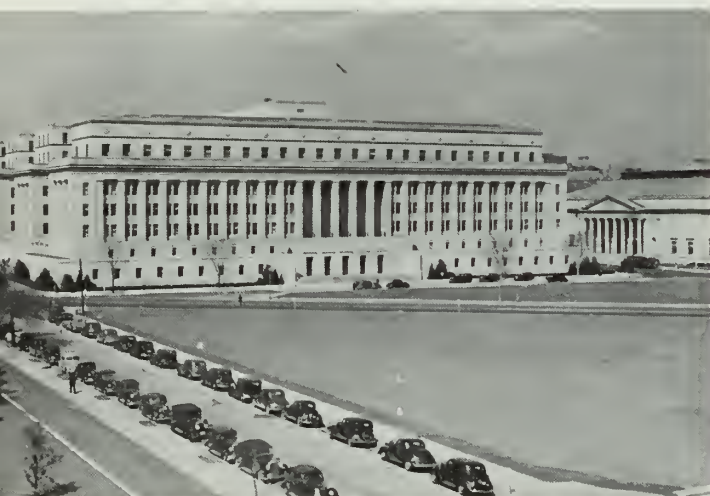
The south elevation (Fig. 13) is symmetrical and consists of a two-story base with a one-story projecting stylobate, a three-story superstructure with cornice, a two-story attic with monumental frieze, and a penthouse, which is normally not seen from the ground. The roof of the penthouse is approximate-

**Windows:** The stylobate has one double hung window (one-over-one) per bay except for the end bays, which do not have windows. The windows on the second floor are casements with a single pane of glass and a recessed rectangular panel above (Fig. 13).

**Typical Bays and End Bays:** Flanking the loggia are 10 identical bays and an end bay (Figs. 13 and 20). The typical bays are separated by three-story pilasters with a simple capital (Model No. 3, not illustrated) of the same design as the piers of the loggia. A plain architrave rests above the pilasters.

**Entablature:** Above the fifth story is an entablature running the entire length of the building (Figs. 13 and 20). The simple classical cornice is Model No. 4 (not illustrated). Above the cornice is a plain parapet wall with a simple tubular railing, painted medium gray. Below the cornice is a plain frieze. Between the entablature and the architrave is a row of guttae, extending the length of each bay.

The sixth and seventh stories are set back from the main façade, forming a monumental attic (Fig. 13). These two floors are also set back one bay on each end resulting in a total number of 25 bays.

The north elevation of the Interior Building is not as monumental in design as the south elevation, although the general features are similar (compare Figs. 13 and 22).

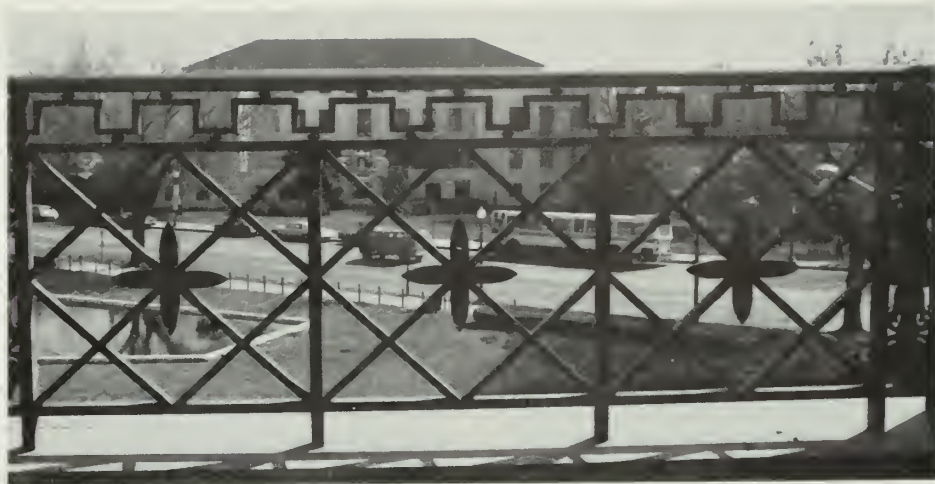
17

17. BRONZE RAILING, SOUTH LOGGIA, SOUTH ELEVATION. The railing is Model No. 103 and has a statuary bronze finish (see also Fig. 283). David Look and Carole Perrault, 1976, Photo No. 362-12, Technical Preservation Services Division, Office of Archeology and Historic Preservation, Heritage Conservation and Recreation Service (cited hereafter as HCRS), Washington, D.C.

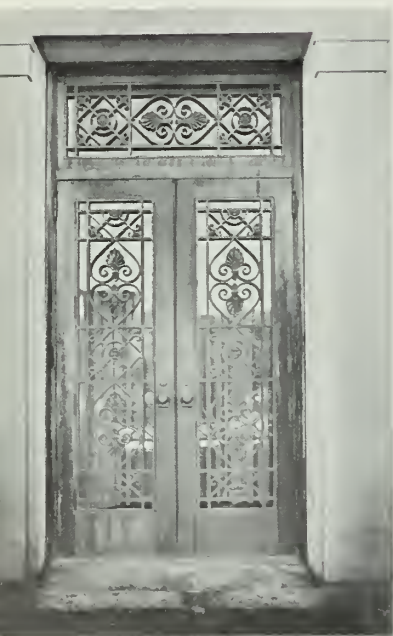
18

18. ORNAMENTAL BRONZE AND GLASS DOORS, SOUTH LOGGIA, SOUTH ELEVATION. The grilles on the doors are Model No. 101 and the grille on the transom is Model No. 102 (see Fig. 283). Brooks Photographers, Bethesda, Maryland, 1976, HABS Collection.

The center bay of the loggia at the third-story level has a set of double bronze doors with transom (Fig. 16 and 18). For a discussion of the design of the doors, see Fig. 283. The trim of the doors resembles the piers of the façade. Above the doors is a pediment with cornice (Fig. 16). The windows of the loggia are doubled-hung, one-over-one. The sash and frames are of clear stock, Southern pine, painted a medium gray. The third and fourth stories have one window per bay. These windows are related visually by being recessed in a tall vertical rectangle with a double-recessed rectangular panel between the windows. The fifth story has two windows per bay, similar to the typical bay of the majority of the façade. Between the fourth and fifth stories is a simple cornice at the level of the windowsills.

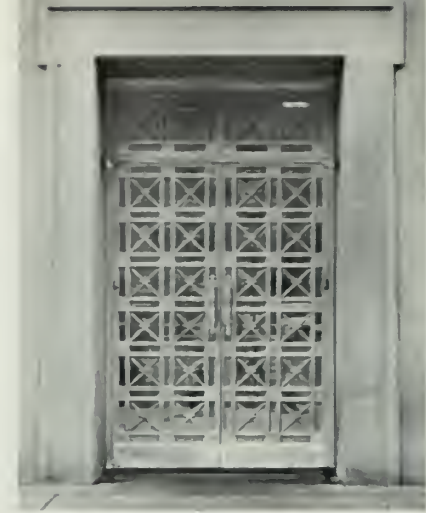
23

23. BRONZE DOUBLE DOORS, NORTH ELEVATION. The north entrance doors (Model No. 100, see Fig. 283) are smaller than those of the south entrance (Fig. 15) and the door surrounds are of limestone rather than granite. The hardware (Fig. 295) is identical to that of the south doors. Brooks Photographers, Bethesda, Maryland, 1976, HABS Collection.

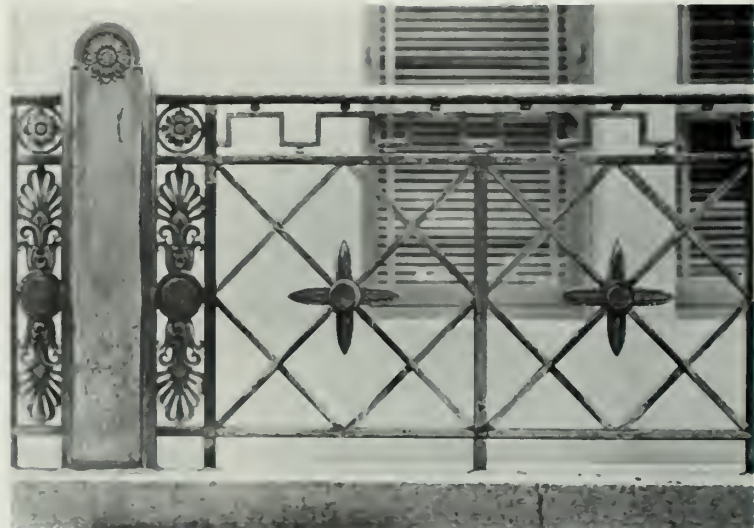
25

25. BRONZE RAILING ALONG THE WINDOW AREAWAY, NORTH ELEVATION. The design (Model No. 104, see also Fig. 283) is similar to the railing of the South Loggia (Model No. 103, see Fig. 17). Brooks Photographers, Bethesda, Maryland, 1976, HABS Collection.

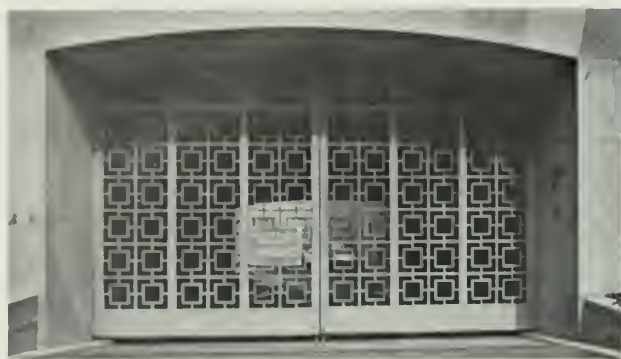
28

The stylobate is interrupted by the entrances to parking and the loading platforms where height clearance does not permit an arch at Courts C, D, G, and E. The ramps to the courts are 26 feet wide. A segmental arch forms the court entrance. All entrances except for Court F have a cast-iron gate (Fig. 28). The gate pattern consists of three large, vertical, rectangular panels. Within each panel are two columns of six designs; each design consists of a square suspended by short posts within a square. The design varies somewhat at the top edge to account for the arch. The archway is constructed of Guastavino tile and is centered by an etched glass and bronze light fixture. The sidewalks on the ramp are granite, while the ramp surfacing varies from asphalt to 3-inch granite block paving laid in an intersecting fan pattern (Fig. 29).

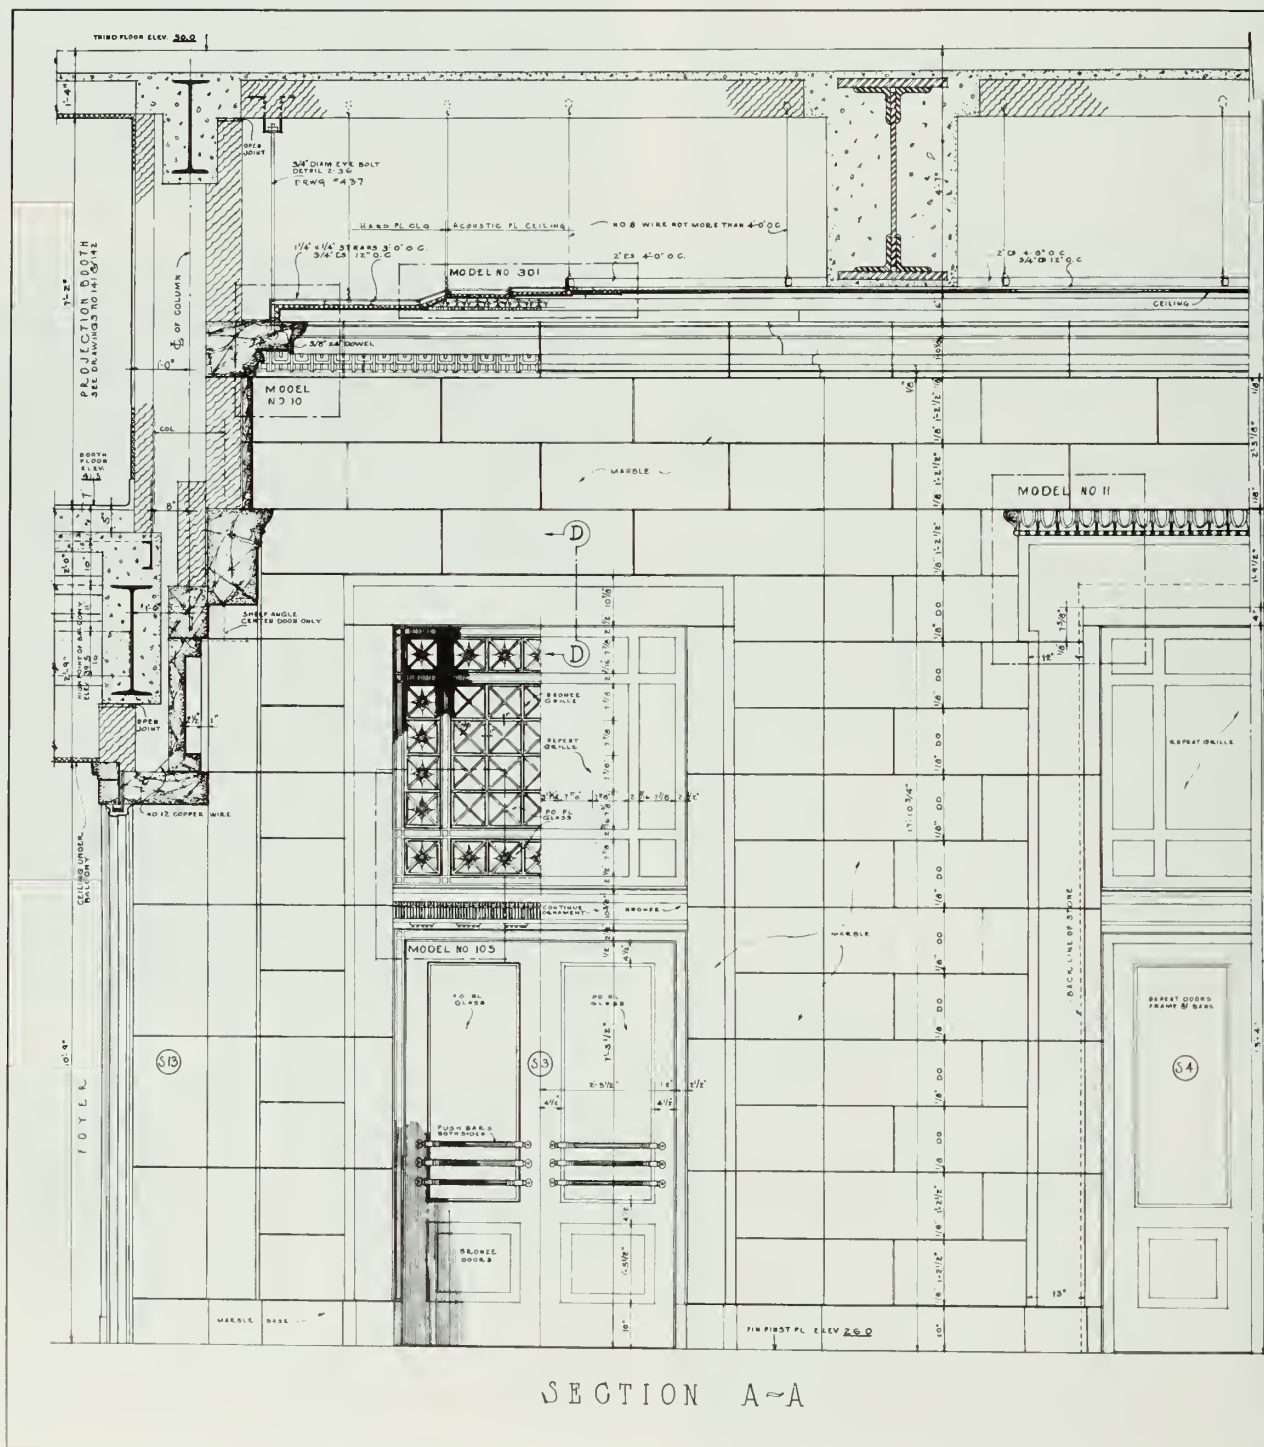
30. SECTION, LOBBY, SOUTH ENTRANCE, FIRST FLOOR. The drawing is a section cut through the South Lobby at the southeast corner. This view is looking south and shows the steel structure, wall construction, cornice and door treatments. Detail of Drawing No. 215, by Rieber and Harper, May 1, 1935. Document stored at the National Record Center, Suitland, Maryland. Record Group 121-76-301, Box 86, No. DC 0020 ZZ 190.

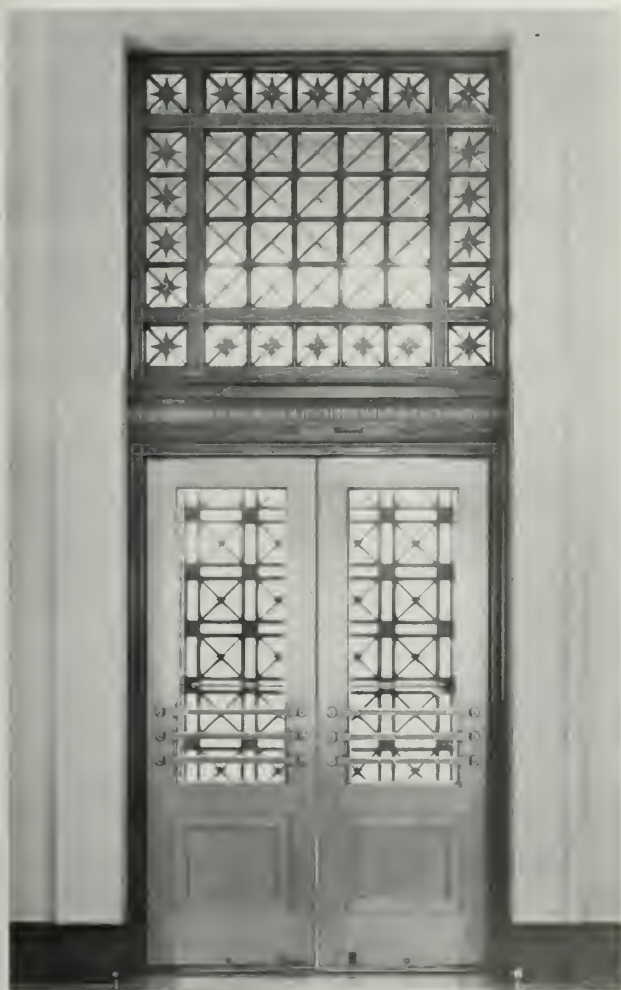
31

31. BRONZE AND GLASS DOORS, LOBBY, SOUTH ENTRANCE, FIRST FLOOR. The embellished Roman grate design of the transom is Model No. 105 (see Fig. 284) and the design of the crossetted surround with egg-and-dart crown molding is Model No. 11 (see Fig. 273). Brooks Photographers, Bethesda, Maryland, 1976, HABS Collection.

All five sets of bronze and glass double doors are identical (Fig. 31). Each of the yellow bronze double doors has a plate-glass window, covering about two-thirds of the upper part of the door. Across the bottom of the window are three push bars and be-

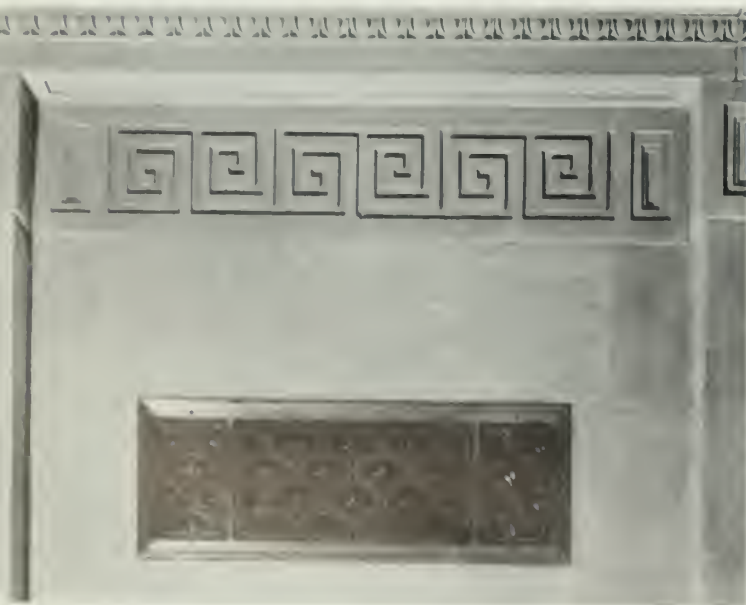
The walls of the one-and-a-half story South Vestibule are smooth buff Indiana limestone laid in a regular ashlar pattern. At the top of the walls is a running Greek fret design below and egg-and-dart molding and a plain projecting cornice (Fig. 34). At the bottom of the walls is a Champlain black, polished, marble base (10 inches high). On the south side of the South Vestibule are five bronze and glass double doors. On the north side of the South Vestibule are five lacquered, two tone bronze and glass doors. (For detailed descriptions of the exterior and interior sets of doors, see the discussion of the South Elevation and the South Lobby, respectively.) On the east wall is a bronze

dedication plaque (28 inches by 56 inches) surrounded by an egg-and-dart molding and surmounted by a cornice of acanthus leaves. Above the dedication plaque and at the same location on the opposite wall is a rectangular bronze grille (15 inches by 40 inches). The grille design consist of four rows of lilies under intersecting staggered arches (Model No. 190, Figs. 34 and 286).

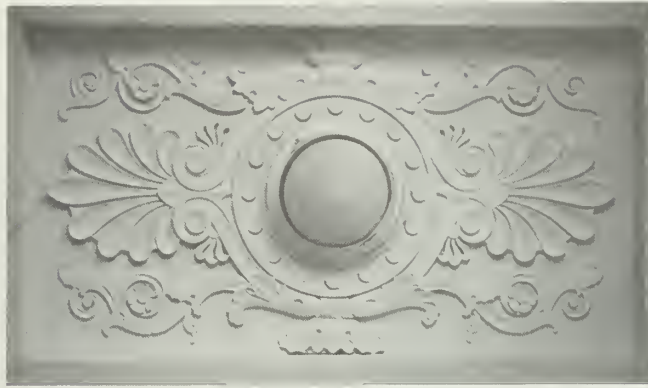
36

36. DETAIL OF CEILING, SOUTH VESTIBULE, SOUTH ENTRANCE, FIRST FLOOR. Acoustic stone panel is Model No. 300 (see Fig. 276) and the bronze lighting fixture with frosted bowl is Model No. 325 (see Fig. 282). David Look and Carole Perrault, 1976, Photo No. 339-9. Technical Preservation Services Division, Office of Archeology and Historic Preservation, HCRS, Washington, D.C.

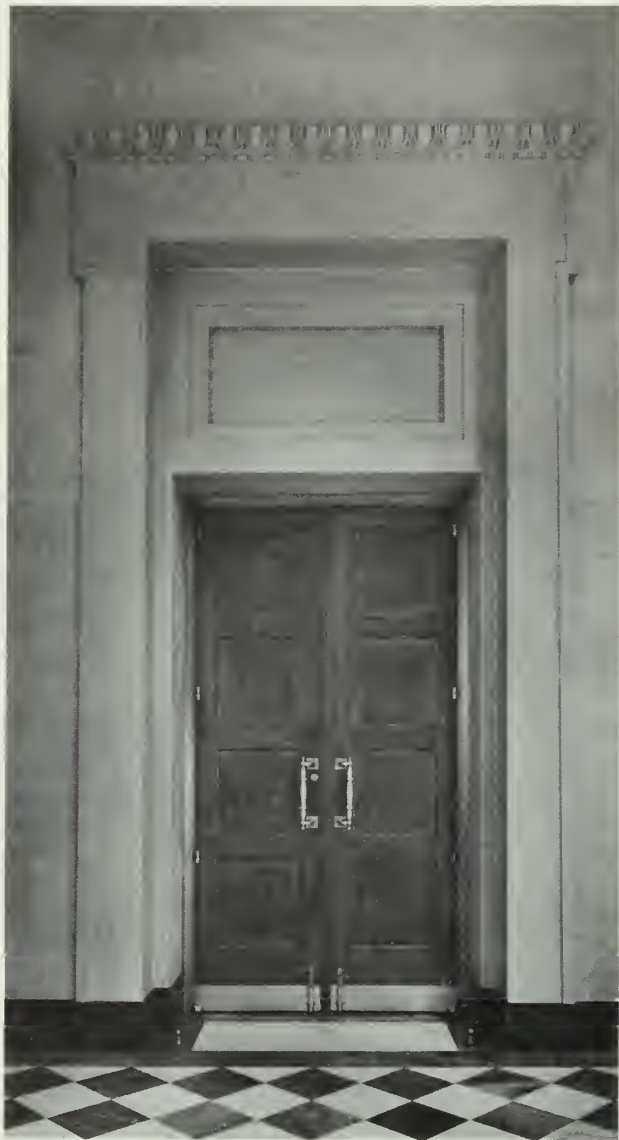
39

39. AUDITORIUM DOOR, SOUTH LOBBY, SOUTH ENTRANCE, FIRST FLOOR. The mahogany double doors have a double-recessed limestone panel above and a limestone surround with cornice, Model No. 11 (see Fig. 273). The doors have Russwin hardware (see Figs. 292 and 293). Brooks Photographers, Bethesda, Maryland, 1976, HABS Collection.

**East Wall:** The east wall of the South Lobby has three sets of identical double doors leading to the Auditorium (Conference Hall, Fig. 39). The pylon-like door surrounds and architraves are the same size and design as those of the center three doors on the south wall (Model No. 11, Fig. 273).

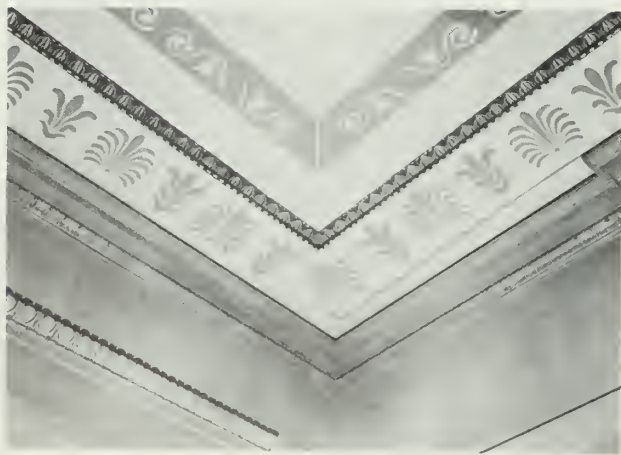
40

40. DETAIL OF CEILING, SOUTH LOBBY, SOUTH ENTRANCE, FIRST FLOOR. Two bands of ceiling stenciling surround the room, painted in shades of gray (see Fig. 296). The limestone cornice is Model No. 11 (see Fig. 273) and the plaster ceiling molding is Model No. 301 (see Fig. 275). Brooks Photographers, Bethesda, Maryland, 1976, HABS Collection.

recessed, rectangular section of acoustic plaster (Fig. 40) installed by the Acoustical Installation Corp. of New York City. Surrounding the expense are two bands of stenciling between which is a leaf and-dart molding above a bead and reel (Model No. 301, Fig. 275). Both the bands and molding are hard plaster. The innermost stenciled design has a medium warm gray band with a white Greek scroll design. The outer border of the stenciled design is a gray stylized anthemion band on a white ground.

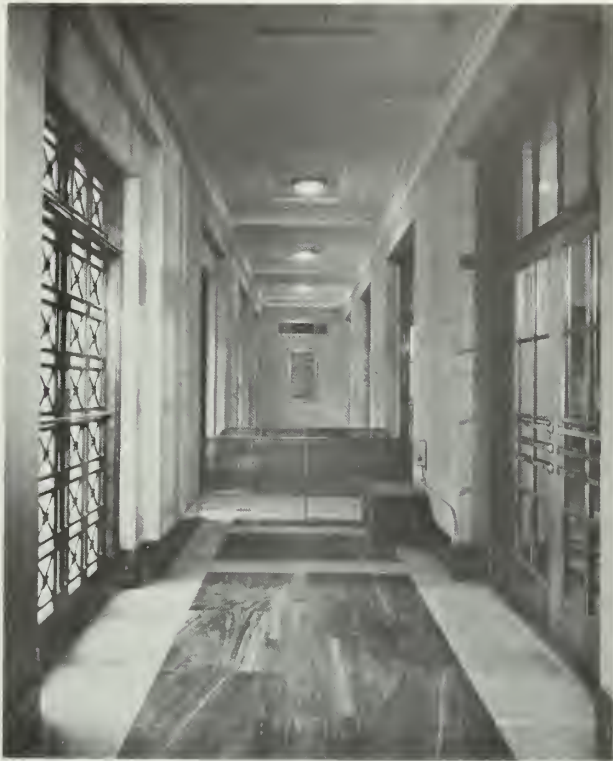
45

45. NORTH VESTIBULE, NORTH ENTRANCE, SECOND FLOOR. View looking east. To assist handicapped persons, the center set of doors was converted to automatic doors in 1972. Brooks Photographers, Bethesda, Maryland, 1976, HABS Collection.

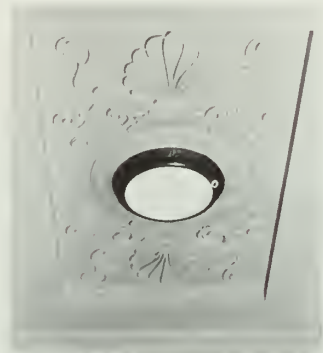
46

46. CEILING, NORTH VESTIBULE, NORTH ENTRANCE, SECOND FLOOR. The ornate hard plaster panel is Model No. 306 (see Fig. 277) and the lighting fixture is Model No. 325 (see Fig. 282). Brooks Photographers, Bethesda, Maryland, 1976, HABS Collection.

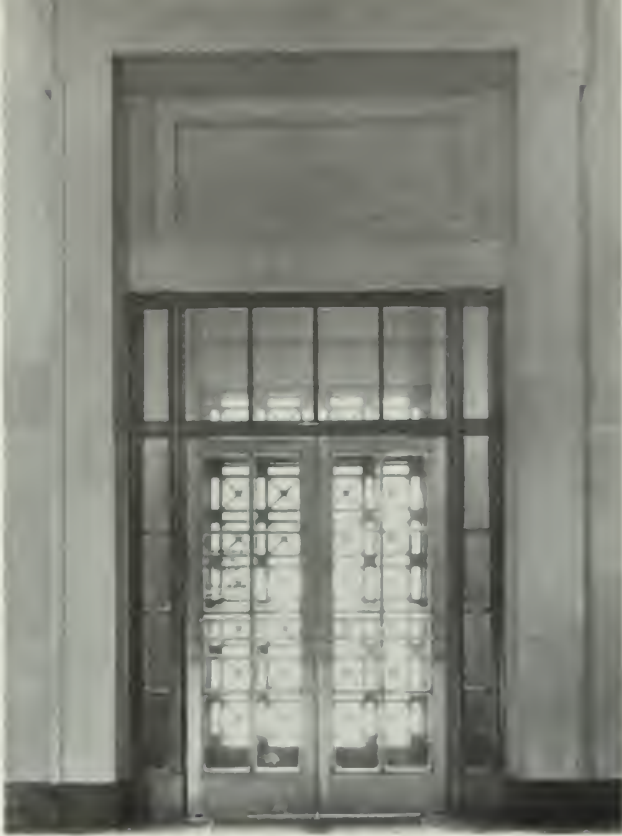
48

48. BRONZE DOUBLE DOORS, NORTH LOBBY, NORTH ENTRANCE, SECOND FLOOR. The double doors of the North Lobby are much simpler than those of the South Lobby (see Fig. 31). The door surround and cornice is Model No. 14. Brooks Photographers, Bethesda, Maryland, 1976, HABS Collection.

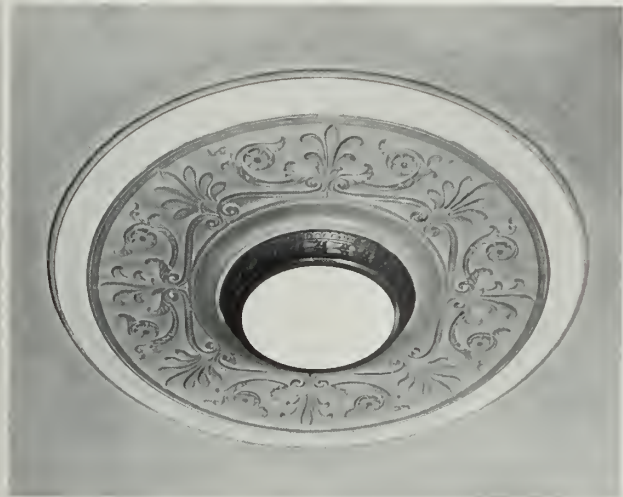
52

52. CEILING MEDALLION AND LIGHTING FIXTURE, NORTH LOBBY CORRIDOR, NORTH ENTRANCE, SECOND FLOOR. The hard plaster ceiling medallion is Model No. 303 (see Fig. 276) and the bronze and glass incandescent lighting fixture is Model No. 325 (see Fig. 282). Brooks Photographers, Bethesda, Maryland, 1976, HABS Collection.

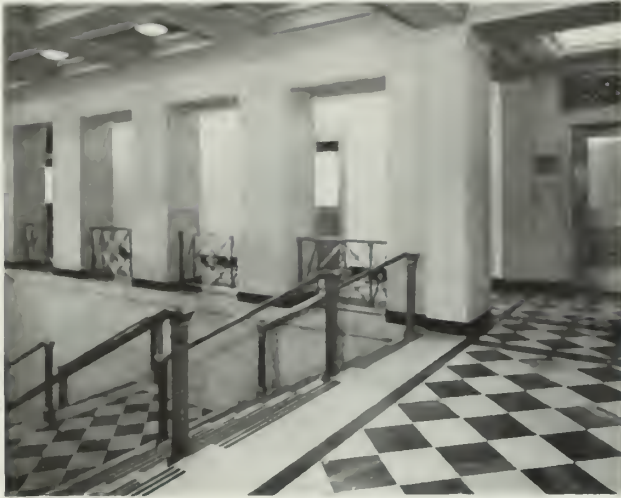
56

56. SIDE AISLE, UPPER GRAND STAIRS, MAIN CORRIDOR, SECOND FLOOR. Colonnades of piers and railings separate the stairs from the side aisles. The bronze grille over the door is Model No. 112 (see Fig. 286). Brooks Photographers, Bethesda, Maryland, 1976, HABS Collection.

The side aisles and intermediate stair landings (Fig. 56) repeat the diagonal, checkerboard pattern found in the main corridor, consisting of white Georgian and dark Creole Georgian marble. The

The outside walls of the side aisles are hard plaster with gray Tennessee marble pilasters and door surrounds (Fig. 56). The fluted pilasters have a capital of stylized leaves, Model No. 15. The base of the walls is Champlain black, polished marble (5 inches high). The side walls of the stairs and the rectangular piers are clad in Tennessee gray marble veneer.

Bronze doors appear between alternating piers on the outside walls of the main corridor (Fig. 56). A louvered panel is in the lower half, and in the upper portion is a large pane of frosted glass. The doors and door surrounds are topped by a patterned bronze grille (Model No. 112, Fig. 286). The grille is 20 inches by 15 inches and includes three rows of nine repetitive designs. Each design consists of a

The piers between the stairs and side aisles do not have capitals. Above the piers is a Doric molding over a stylized wave design (Fig. 56).

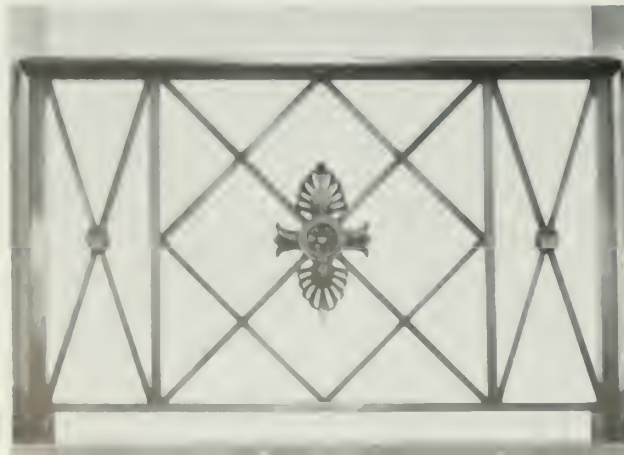
61

61. UPPER GRAND STAIRS, MAIN CORRIDOR, FIRST FLOOR. Handrails divide the stairs into three sections. Below the second floor the stairs are separated from the side aisles by a solid wall. Brooks Photographers, Bethesda, Maryland, 1976, HABS Collection.

Railings appear along the side walls of the stairs (Fig. 61). Two center railings divide the stair space into three sections. Each railing consists of a bronze handrail and bronze newel posts (Fig. 62). The newels are square, fluted posts with anthemion and stylized Ionic scrolls on square bases (Model No. 121, Fig. 286).

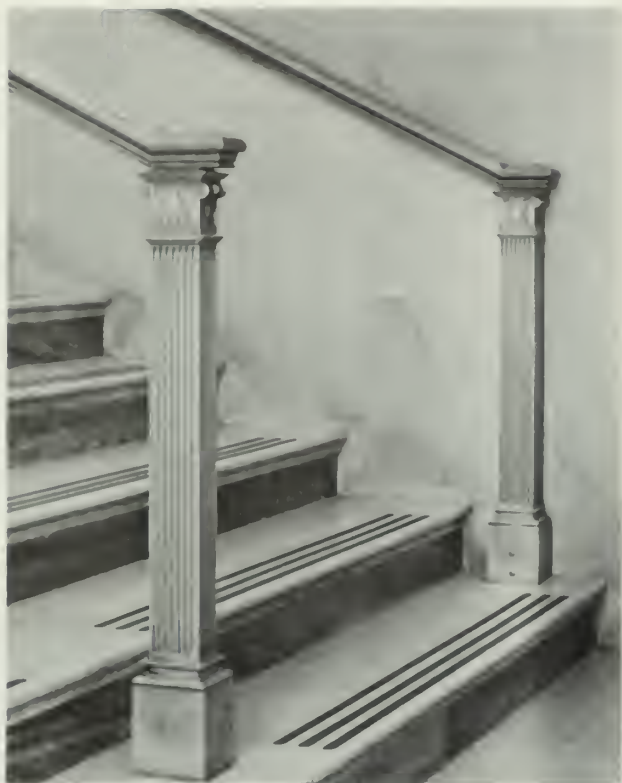
62

62. BRONZE NEWEL POST, GRAND STAIRS. Detail of bronze handrail and newel post (Model No. 121, see Fig. 286). The stair risers are white Georgian marble with sand rubbed finish and stair treads feature dark Creole Georgian marble with a polished finish. Brooks Photographers, Bethesda, Maryland, 1976, HABS Collection.

side aisles are bordered by a 15-inch band of dark Creole Georgian marble, whereas the intermediate stair landings are bordered by a 14½-inch band of white Georgian marble. The thresholds to the side aisles are defined by a band of dark Creole Georgian marble. The stair treads are white Georgian marble with a sand-rubbed finish. A safety tread has been created by three strips of an abrasive filler. The stair risers are in contrasting dark Creole Georgian marble with a polished finish (Fig. 62).

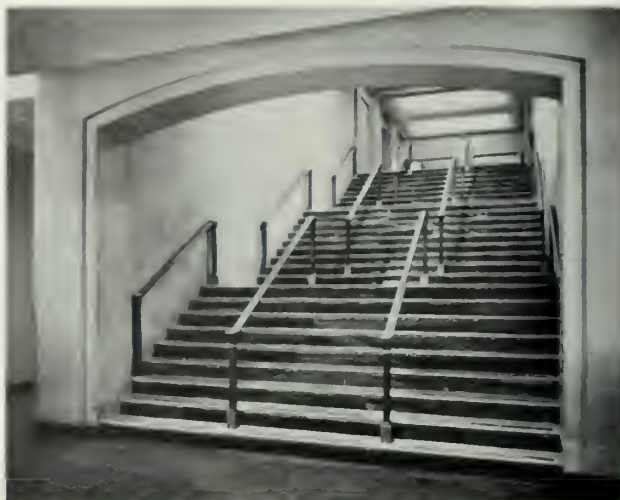
65

65. LOWER GRAND STAIRS, MAIN CORRIDOR, BASEMENT. View of stairs from basement landing with segmental arch in foreground. Brooks Photographers, Bethesda, Maryland, 1976, HABS Collection.

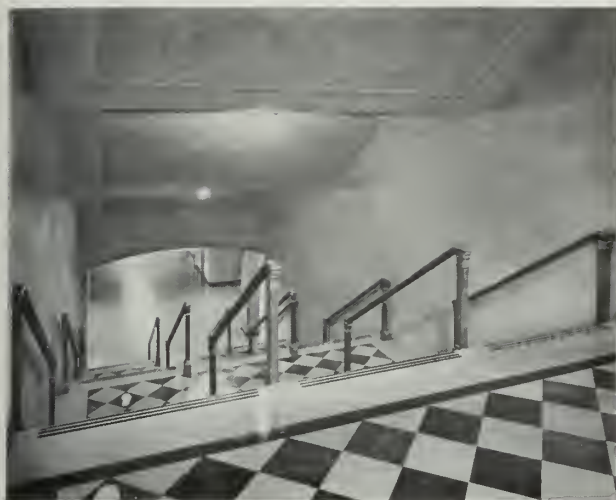
66

66. LOWER GRAND STAIRS, MAIN CORRIDOR, FIRST FLOOR. View showing ceiling treatment. The acoustic plaster ceiling has been painted light blue. Brooks Photographers, Bethesda, Maryland, 1976, HABS Collection.

The ceiling of the lower level of the Grand Stairs slopes parallel to the stairs, except at the landings where it is level (Fig. 66). The ceiling panels feature a hard plaster border surrounding a central panel of acoustic plaster, painted the original sky blue. The panels are centered by a simple, round, incandescent light fixture (Model No. 341, Fig. 282) with a wreath of berries and leaves as the only ornamentation on the bronze rims.

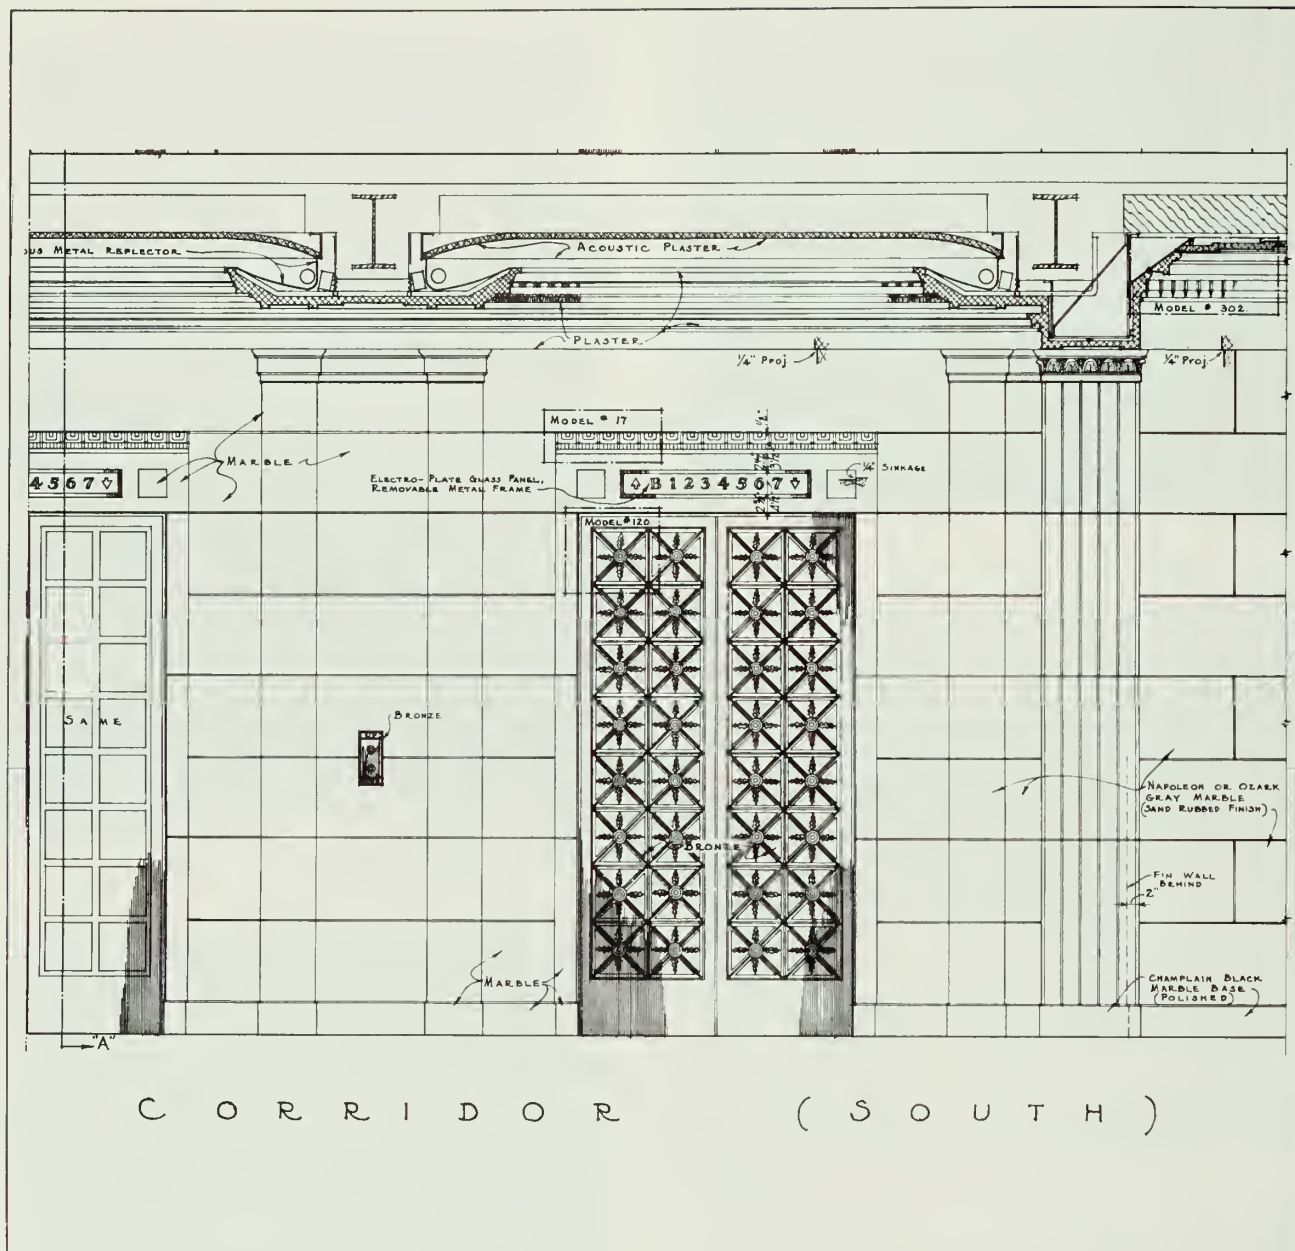
67

67. SECTION, MAIN CORRIDOR, FIRST FLOOR. Section through the main corridor at the elevator lobby illustrating floor construction, light cove with acoustic plaster, bronze elevator doors, pilasters and wall treatment. Detail of Drawing No. 217, by Rieber Winstead, May 1, 1935. Document stored at the National Record Center, Suitland, Maryland, Record Group 121-76-301, Box 86, No. DC 0020 ZZ 192.

The ceiling of the main corridor consists of a series of deeply recessed light coffers (Fig. 67). This type of indirect lighting was used in the Department of Labor Building, built several years earlier in the Federal Triangle (corner of Fourteenth Street and Constitution Avenue, NW). The Building Committee felt that the indirect lighting was superior to conventional direct lighting and recommended it to Ickes and Wood. The coffers are covered with acoustic plaster and curve down toward the fluorescent tubes along the edges. Each coffer is surrounded by leaf-and-dart and bead-and-reel moldings (Model No. 304, Fig. 78). Between coffers are double-recessed panels. Between pilasters are dropped, shallow beams of hard plaster, with a recessed panel on the bottom and a plain molding on the sides (identical to the molding along the side walls).

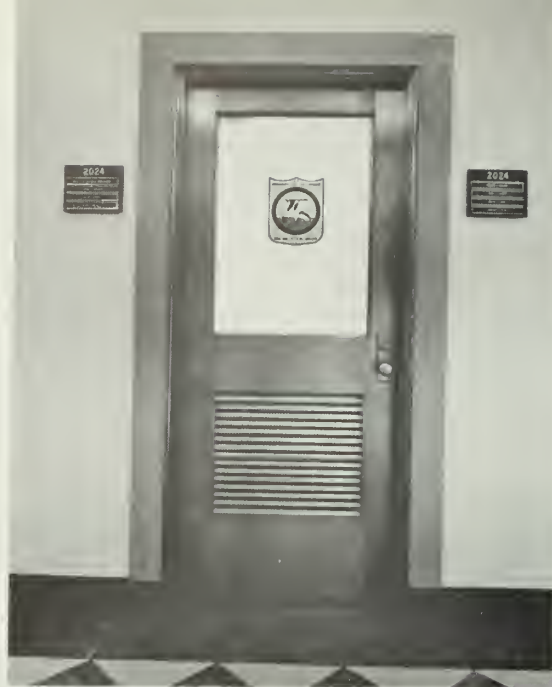
71

71. BRONZE OFFICE DOORS, MAIN CORRIDOR, FIRST AND SECOND FLOORS. On the north half of the main corridor on the first floor, and on the south half of the main corridor on the second floor, the walls are hard plaster and the door surrounds are gray Tennessee marble of a plain rectangular section. Brooks Photographers, Bethesda, Maryland, 1976, HABS Collection.

The hall doors of the main corridor on the first and second floors are lacquered bronze (varying in height from 7 feet 5½ inches to 8 feet 3½ inches) with a glass window, usually frosted, in the top and louvers below. On the south half of the first floor main corridor and the north half of the second floor where the walls are marble (Fig. 68), the bronze doors do not have surrounds. Above these doors is a Doric molding and a recessed marble panel. The doors on the north half of the first-floor main corridor and the south half of the second floor have a marble surround of a plain rectangular section (Fig. 71).

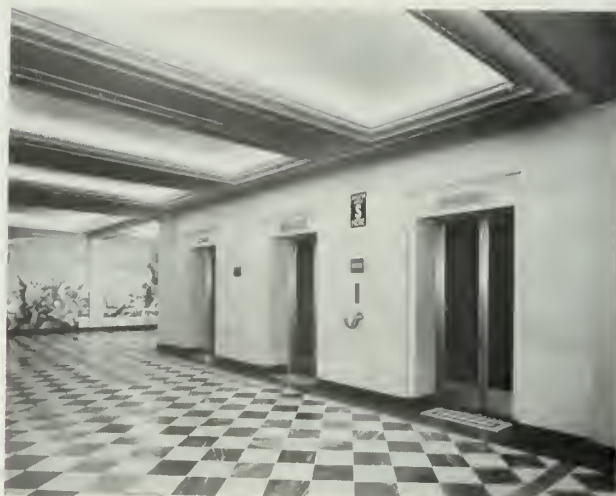
72. ELEVATOR LOBBY NO. 4, MAIN CORRIDOR, SECOND FLOOR. View showing flooring, fluted pilasters, elevator doors, and light coffer. Brooks Photographers, Bethesda, Maryland, 1976, HABS Collection.

The floor treatment of the main corridor on the first and second floors (Figs. 68-70) features a diagonal checkerboard pattern of white Georgian marble and dark Creole Georgian marble with a dark Creole Georgian marble border. At the intersection of the main corridor and secondary corridors, and at each end of the elevator lobbies, dark Creole Georgian marble bands define the boundaries. The threshold of each elevator (Figs. 72 and 73) is a white Georgian marble rectangle sur

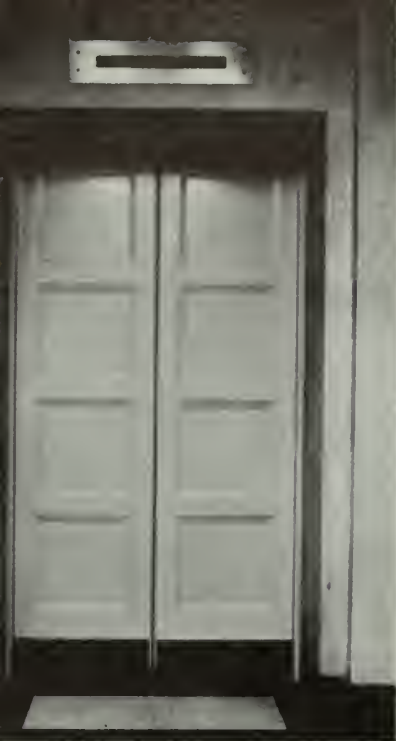
81

81. TYPICAL ELEVATOR DOORS, THIRD THROUGH SEVENTH FLOORS. The elevator doors on the third through the seventh floors are painted, hollow metal. Brooks Photographers, Bethesda, Maryland, 1976, HABS Collection.

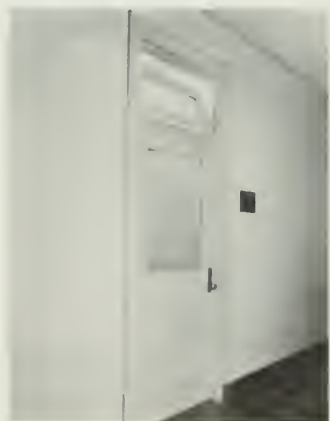
84

84. TYPICAL OFFICE DOOR, THIRD THROUGH SEVENTH FLOORS. The typical door is of metal with transom and metal surround. Brooks Photographers, Bethesda, Maryland, 1976, HABS Collection.

The typical door is a painted hollow metal door 7 feet high by 2 feet 8 inches wide, with transom. Each door has a frosted glass window, with louvers below.

The walls of the side corridors are hard plaster with a small simple cornice molding and a black Champlain marble 6-inch base. There are 3,681 interior doors. The typical door (Fig. 84) is painted metal, 7 feet high by 3 feet wide, with an operable transom. Each door has a frosted glass window, with louvers below. Restroom doors are the same as office doors except that they do not have glass windows. Doors to the stairs are double metal without transom. Each stair door has a wire glass window with a panel below, without louvers (Fig. 83).

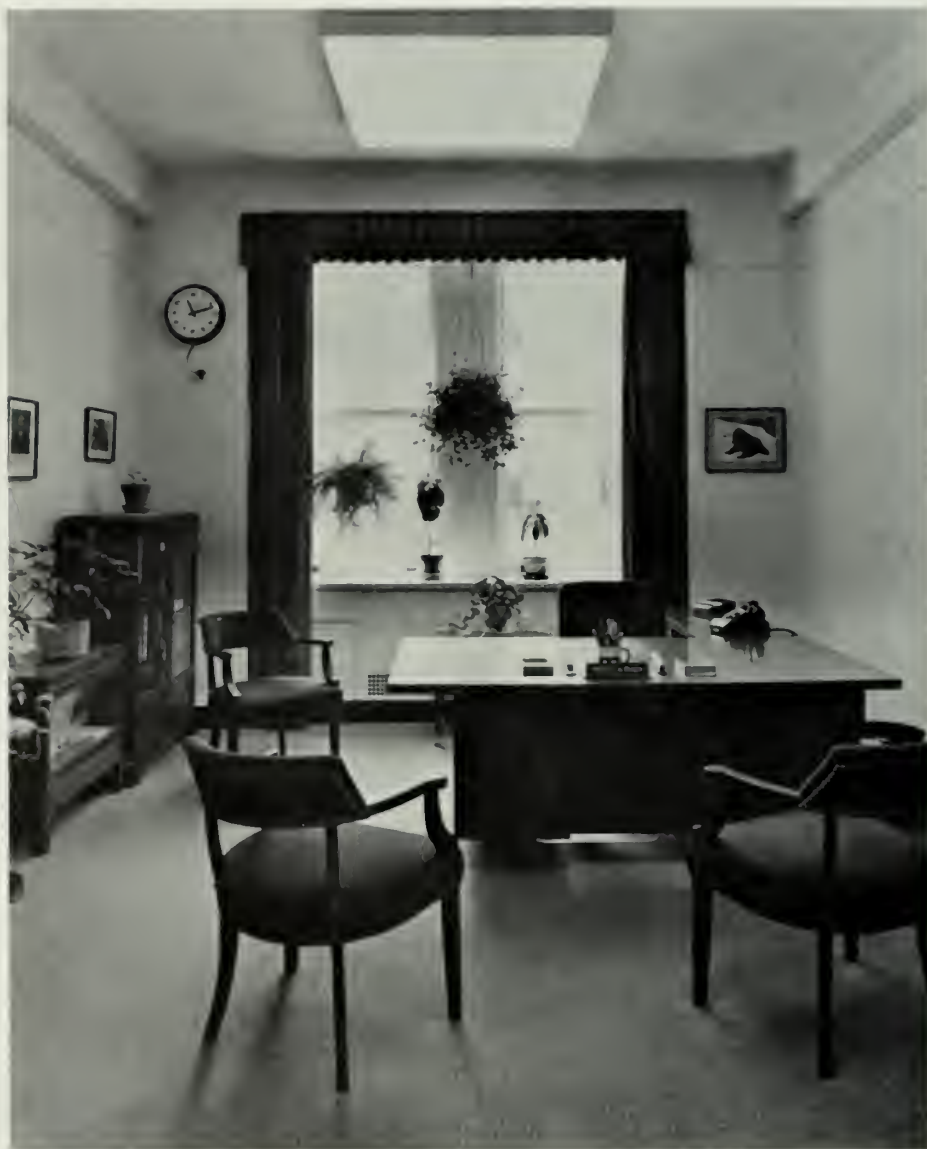
85

85. TYPICAL OFFICE, FIRST THROUGH SEVENTH FLOORS. Each office has windows for natural light and a door for direct access to a corridor. Brooks Photographers, Bethesda, Maryland, 1976, HABS Collection.

tween offices are painted without windows or transoms. Most offices (Fig. 85) have two windows, side by side. They are operable wood double-hung windows, one-over-one. Between the windows is a tall, narrow recessed panel. The heating, air-conditioning, and ventilating system is in a metal cabinet below the windows.

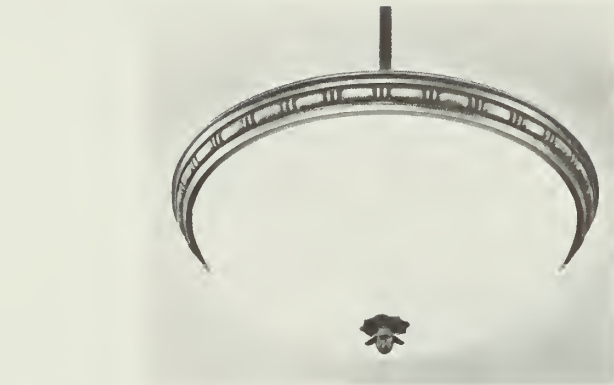
87. ORIGINAL OFFICE LIGHTING FIXTURE, ROOMS 7260 AND 7261, WING 7200 WEST, SEVENTH FLOOR. This incandescent fixture is Model No. 335, Type N (see Fig. 281). Brooks Photographers, Bethesda, Maryland, 1976, HABS Collection.

The white acoustic plaster ceiling has a projecting wood soffit. The distinguishing element that makes these two offices significant is that they still have their original light fixtures (Model 335, Type N, Figs. 87 and 281). In 1967, most of the corridor and office incandescent fixtures were replaced with fluorescent fixtures. On May 8, 1967, Mr. Harry Shooshan, Director of Resources Program Staff, requested that the original incandescent fixtures be retained in his office (Fig. 86). Although we do not know what light fixtures other offices in the building had, Rooms 7260 and 7261 provide us with an idea of the original lighting configuration and appearance of an office space. (For detailed description of these light fixtures see Fig. 281).

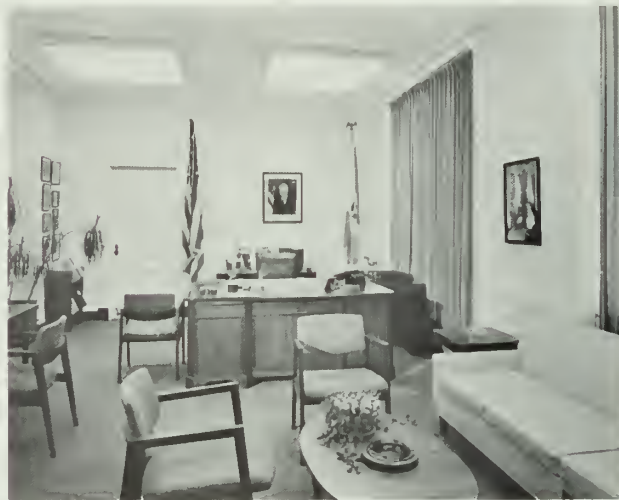
90

90. ROOM 6610, WING 6600 EAST, SIXTH FLOOR. This office has hard plaster walls with fluted pilasters flanking the windows and flush panel wainscot below the chair rail. Brooks Photographers, Bethesda, Maryland, 1976, HABS Collection.

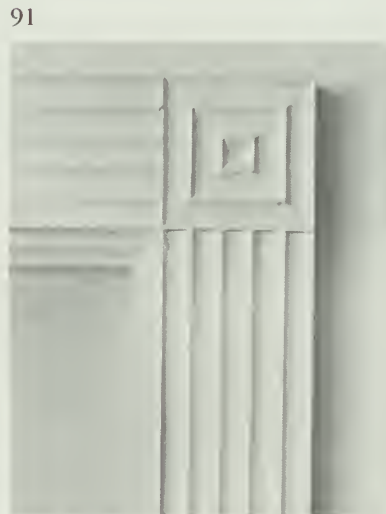
91

91. DOOR SURROUND AND CORNER BLOCK, SUITE 6616, WING 6600 EAST, SIXTH FLOOR. Detail of wooden fluted door surround and corner block of concentric squares. Brooks Photographers, Bethesda, Maryland, 1976, HABS Collection.

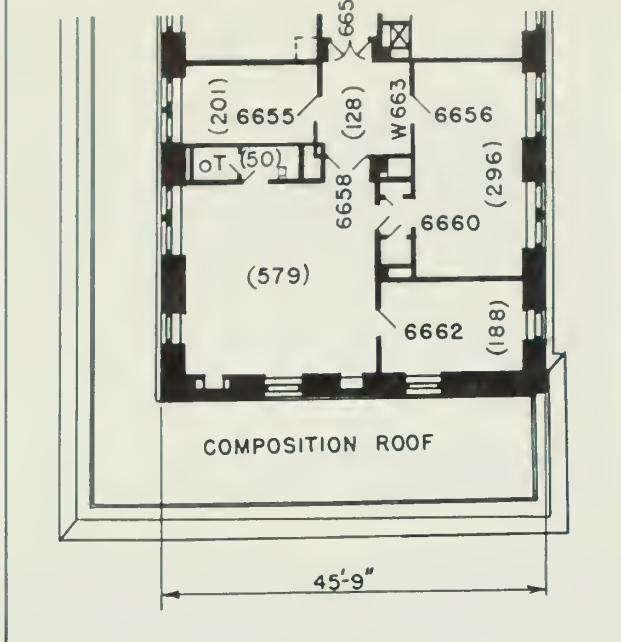
92

92. FLOOR PLAN, SUITE 6654, WING 6600 WEST, SIXTH FLOOR. Suite 6654 is the Office of the Assistant Secretary for Energy and Minerals. Detail of the Sixth Floor Plan, Revised by the Federal Works Agency, Public Building Administration, Office of Buildings Management, 1947. Document stored at the National Record Center, Suitland, Maryland, Record Group 121-76-301, Box 83, No. DC 0020 ZZ 18.

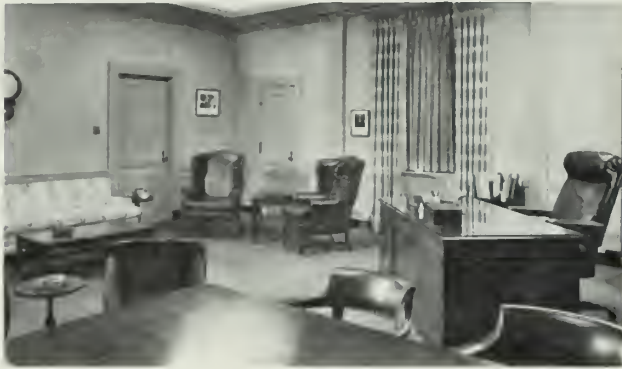
93

93. ROOM 6658, SUITE 6654, WING 6600 WEST, SIXTH FLOOR. Room 6658 has fluted wooden pilasters flanking the windows and a flush paneled wainscot below the chair-rail. Brooks Photographers, Bethesda, Maryland, 1976, HABS Collection.

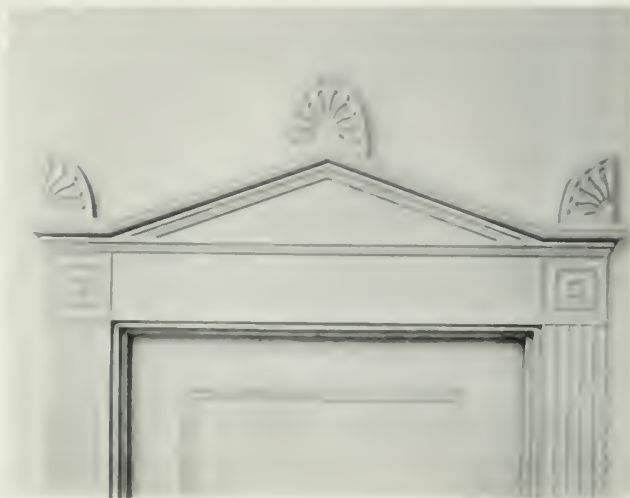
97

97. DOOR PEDIMENT AND SURROUND, SUITE 5116, WING 5100 EAST, FIFTH FLOOR. The classical wooden pediment with Greek antifixae is Model No. 201 (see Fig. 275). Brooks Photographers, Bethesda, Maryland, 1976, HABS Collection.

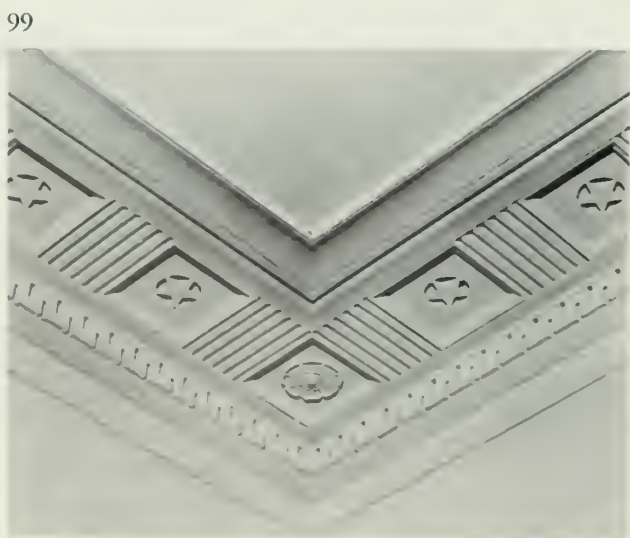
99

99. SOFFIT, ROOM 5108, SUITE 5116, WING 5100 EAST, FIFTH FLOOR. The wooden soffit is Model No. 202 (see Fig. 275). Brooks Photographers, Bethesda, Maryland, 1976, HABS Collection.

The ceiling of Room 5108 features a wood soffit above a simple Greek fret molding (Fig. 99). The soffit (Model No. 202, Fig. 275) consists of square, recessed panels with a five-pointed star inscribed in a circle in the middle of each square panel. The corner soffit panel has an Ionic rosette instead of a star. Separating these decorative panels are reeded sections. Between the soffit and the hard plaster ceiling is a cavetto molding with bead. Ceiling fixtures are square, fluorescent with translucent diffusers (not original).

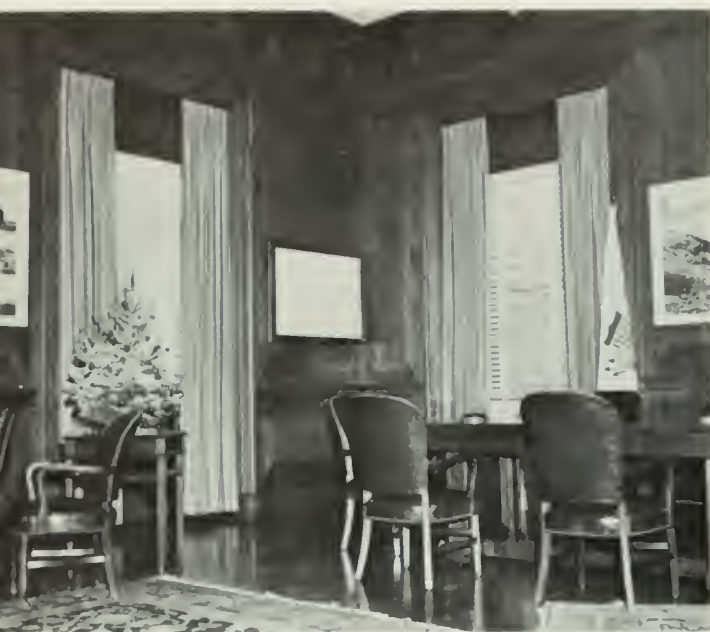
107

107. WALNUT FLOORING, OFFICE OF THE SECRETARY OF THE INTERIOR, ROOM 6156, SUITE 6000, WING 6100 WEST, SIXTH FLOOR. View of the northwest corner of the office showing random width black walnut pegged flooring. National Park Service Historic Photograph Collection (photographer unknown), 1963.

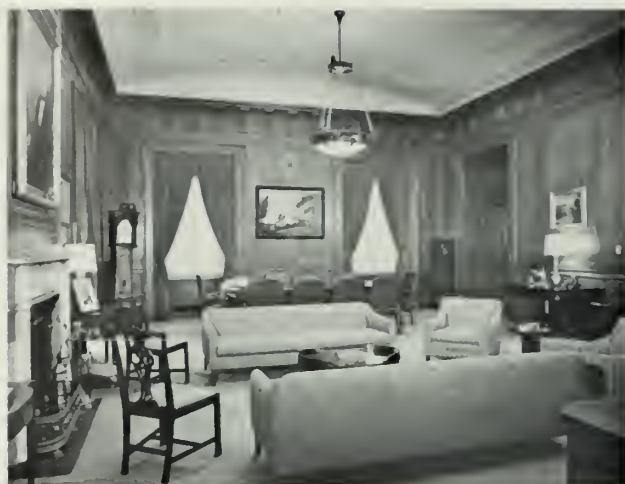
108

108. OFFICE OF THE SECRETARY, ROOM 6156, SUITE 6000, WING 6100 WEST, SIXTH FLOOR. View of the office looking northeast. Brooks Photographers, Bethesda, Maryland, 1976, HABS Collection.

The ceiling (Fig. 108) is a shallow, segmental vault rising from 10 feet 3 inches on the sides to 17 feet in the center. The vault is constructed of layers of thin tile by R. Guastavino Company. The lunette is hard plaster with three double-recessed panels that take their shape from the curve of the vault. The vault is covered with acoustic plaster and is embellished with two hard plaster ceiling medallions (Model No. 321, Figs. 115 and 279) and a hard plaster, bas-relief anthemion band border (Model No. 320, Fig. 109). The two chandeliers with antique bronze finish (Model No. 339, Type R, Figs. 115 and 280) were specially designed for this office and feature buffalo heads on the rim. The medallion is 6 feet in diameter and the chandelier is 34 inches in diameter. The chandeliers weigh 300 pounds each and were fabricated by the Mutual Metal Manufacturing Company of Chicago, Illinois. (For a description of the design of the plaster medallion and bronze chandelier see Fig. 280.) The chandeliers originally had alabaster bowls with concentric rings and a pineapple-like ornament. The design was modified in 1964 when down lights were installed.
